ADVOCATES FOR HERRING BAY
OYSTER RESTORATION REEF IN HERRING BAY

2022 MONITORING REPORT
January 13 2023

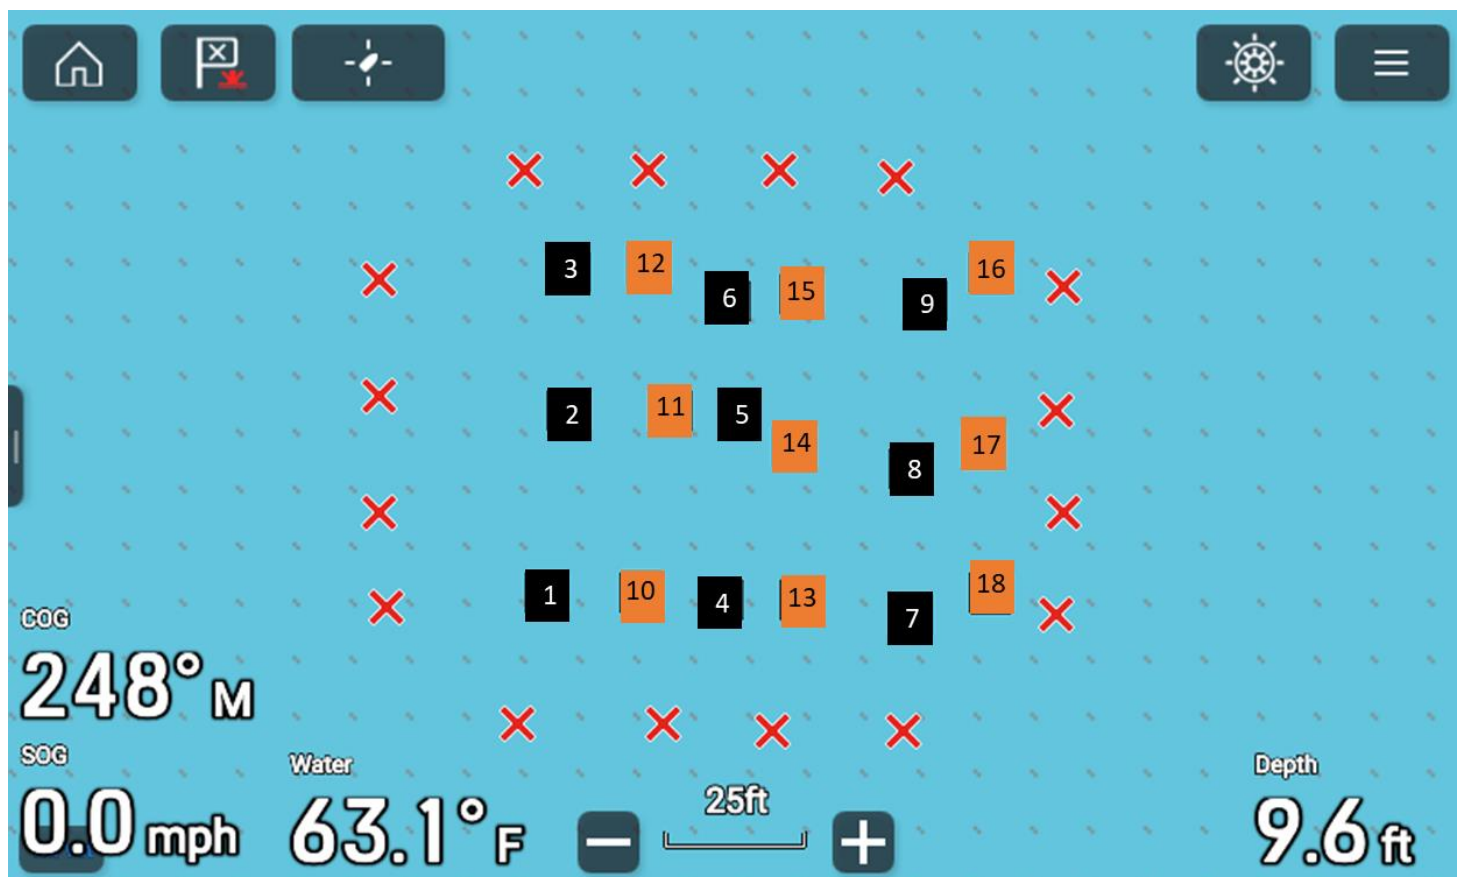
Figure 1: Sample points from 9/26/22 and 10/6/22

AHB's oyster population survey was conducted by a team of divers on September 26 and October 6, 2022. A total of 18 samples were taken, spacing 9 sample points throughout the area on each day.* The various locations of these points are shown in Figure 1.

Sample Sites – ■ September 26th Dive ■ October 6th Dive

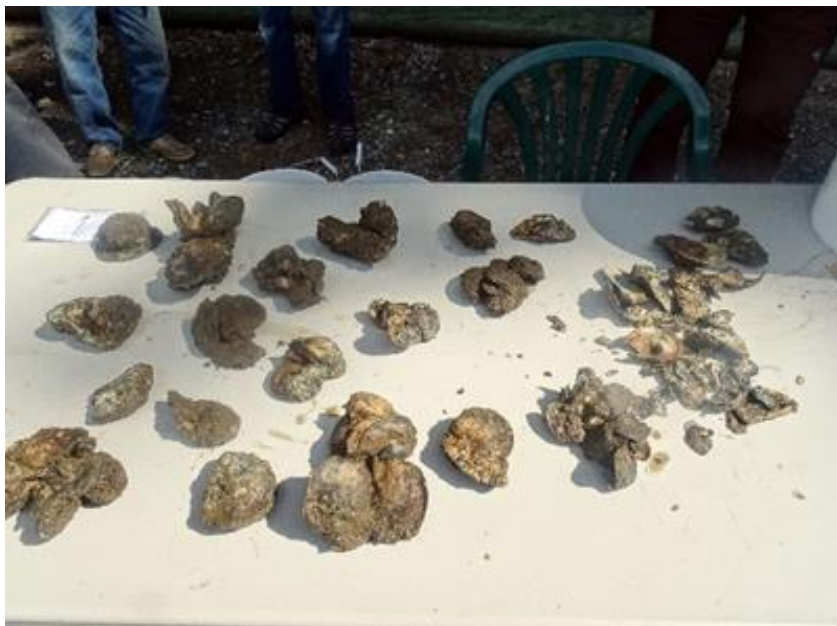
Sample 1 - September 26, 2022

Count – Sample 1			
Total	56	4	1
	Live	Box	Scar
1	2		
2	8		1
3	2		
4	1		
5	1		
6	1		
7	1		
8	1		
9	3		
10	1		
11	2		
12	5		1
13	6		
14	10		
15	4		1
16	3		
17	5		1

Sizes in millimeters - Sample 1			
	Live		Dead
1	70		45
2	85		60
3	90		65
4	85		45
5	80		55
6	60		
7	90		
8	95		
9	60		
10	85		
11	70		
12	100		
13	65		
14	95		
15	95		
Min	60		45
Max	100		65
Average	82		54

Volume in Liters - Sample 1

Water		10
Water + Live Oysters		12.5
Live Oysters		2.5
Water		10
Water + All		13
All		3
Cultch		0.5

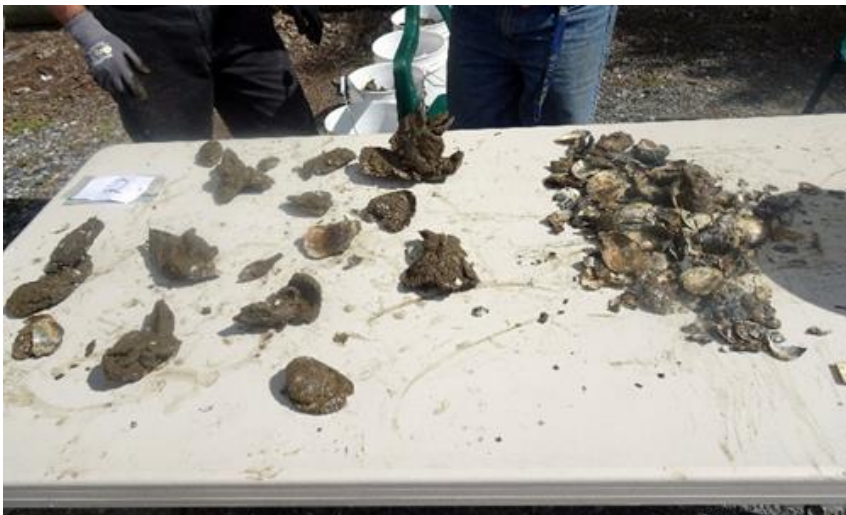
Sample 2 - September 26, 2022

Count – Sample 2			
Total	45	2	0
	Live	Box	Scar
1	6	1	
2	3		
3	1		
4	1		
5	1		
6	1		
7	2		
8	2		
9	1		
10	2		
11	2		
12	1		
13	2		
14	5		
15	7	1	
16	8

Sizes in millimeters - Sample 2			
	Live		Dead
1	110		95
2	90		35
3	45		
4	60		
5	65		
6	50		
7	50		
8	40		
9	80		
10	55		
11	30		
12	60		
13	85		
14	45		
15	55		
Min	30		35
Max	110		95
Average	61		65

Volume in Liters - Sample 2		
Water		7
Water + Live Oysters		8.75
Live Oysters		1.75
Water		7
Water + All		9
All		2
Cultch		0.25

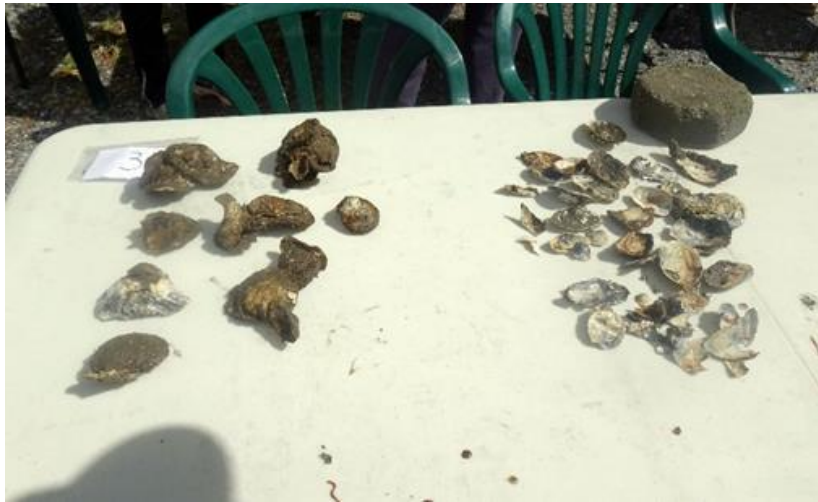
Sample 3 - September 26, 2022

Count – Sample 3			
Total	13	0	3
	Live	Box	Scar
1	1		
2	1		
3	1		
4	1		
5	1		
6	2		2
7	4		1
8	1		
9	1

Sizes in millimeters - Sample 3		
	Live	Dead
1	40	40
2	85	50
3	75	35
4	60	
5	60	
6	75	
7	60	
8	75	
9	80	
10	90	
11	30	
12	70	
13	80	
14	80	
15	65	
Min	30	35
Max	90	50
Average	68	28

Volume in Liters - Sample 3		
Water		4
Water + Live Oysters		4.75
Live Oysters		0.75
Water		4
Water + All		5.25
All		1.25
Cultch		0.5

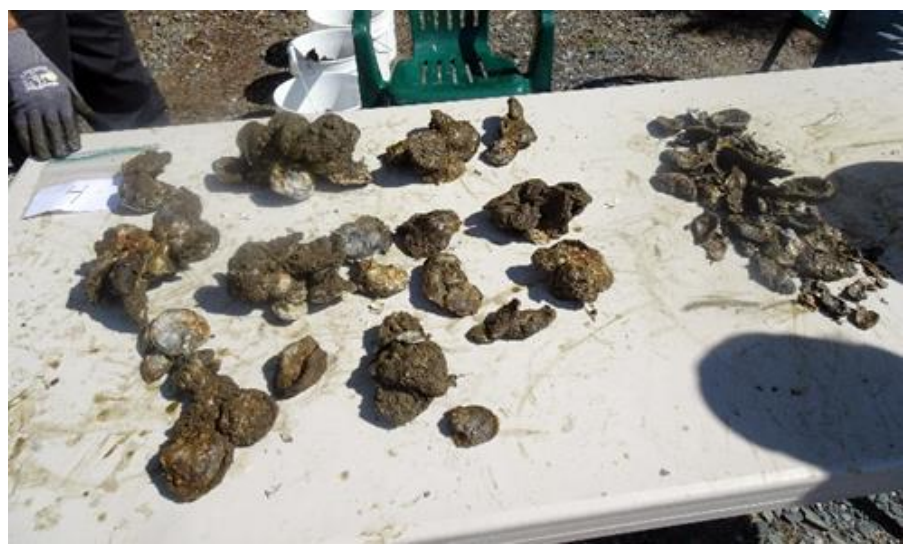
Sample 4 - September 26, 2022

Count – Sample 4			
Total	76	2	0
	Live	Box	Scar
1	15		
2	5		
3	3		
4	10		1
5	3		
6	4		
7	1		
8	1		
9	2		
10	3		
11	1		
12	2		
13	2		
14	1		
15	6		
16	3		
17	7		1
18	7

Sizes in millimeters - Sample 4			
	Live		Dead
1	70		40
2	70		50
3	80		
4	65		
5	60		
6	50		
7	40		
8	65		
9	75		
10	105		
11	65		
12	75		
13	50		
14	70		
15	65		
Min	40		40
Max	105		50
Average	67		45

Volume in Liters - Sample 4		
Water		9
Water + Live Oysters		12
Live Oysters		3
Water		9
Water + All		12.5
All		3.5
Cultch		0.5

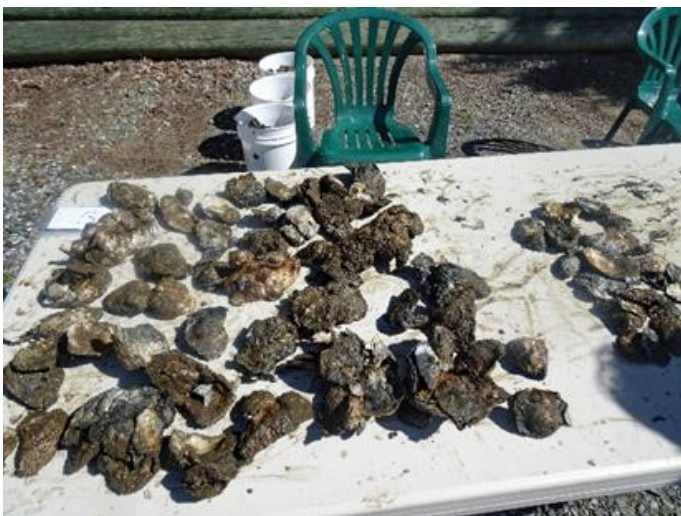
Sample 5 - September 26, 2022

Total	115	13	5
	Live	Box	Scar
1	2		
2	1		
3	1		
4	1		
5	1		
6	1		
7	2		
8	5		
9	1		1
10	3		
11	1		
12	1		
13	2		
14	1		1
15	1		
16	5		
17	2		4
18	3		
19	1		
20	3		
21	1		
22	12		1
23	7		
24	1		
25	1		
26	2		
27	1		
28	11		1
29	1		
30	2		
31	9		
32	4		
33	5		3
34	3		
35	6		1
36	4		4
37	7		1

Live	Dead
1	60	60
2	90	70
3	75	65
4	65	55
5	45	75
6	50	65
7	60	30
8	75	30
9	90	
10	50	
11	95	
12	55	
13	70	
14	40	
15	100	
Min	40	30
Max	100	75
Average	68	56

Water	11.25
Water + Live Oysters	15.5
Live Oysters	4.25
Water	11.25
Water + All	16
All	4.75
Cultch	0.5

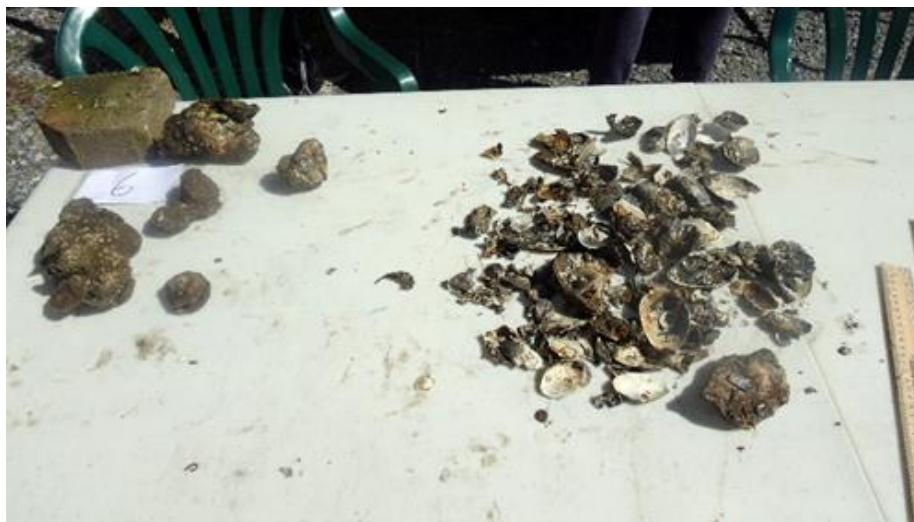
Sample 6 - September 26, 2022

Count – Sample 6			
Total	17	1	0
	Live	Box	Scar
1	2		
2	0	1	
3	5		
4	2		
5	8

Sizes in millimeters - Sample 6			
	Live		Dead
1	45		55
2	50		
3	50		
4	60		
5	45		
6	40		
7	60		
8	50		
9	50		
10	52		
11	65		
12	60		
13	70		
14	80		
15	50		
Min	40		55
Max	80		55
Average	55		55

Volume in Liters - Sample 6		
Water		4.75
Water + Live Oysters		5.5
Live Oysters		0.75
Water		4.75
Water + All		5.75
All		1
Cultch		0.25

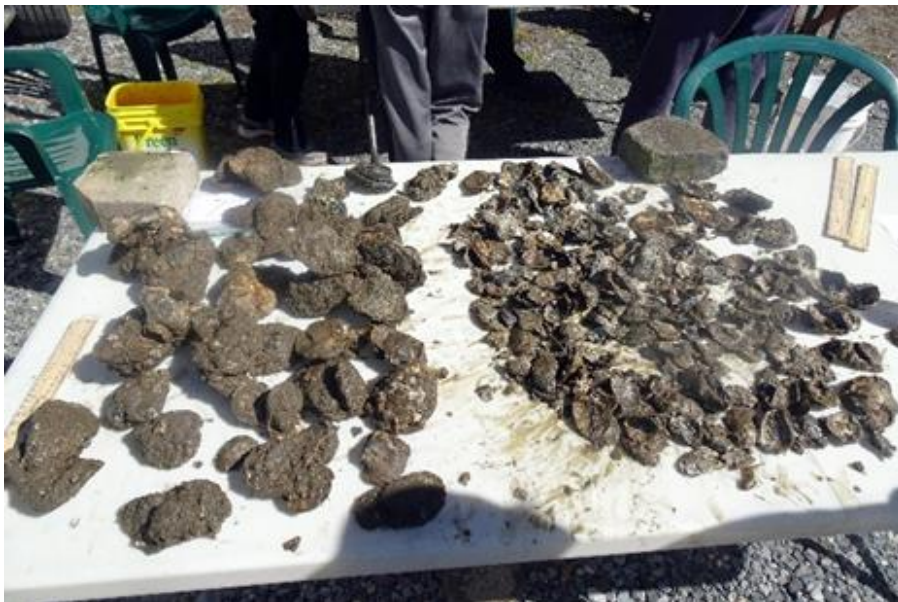
Sample 7 - September 26, 2022

Total	77	3	3
	Live	Box	Scar
1	5		
2	1		
3	6		
4	1		
5	4		1
6	3		
7	1		
8	2		
9	2		
10	1		
11	3		
12	3		
13	1		
14	1		
15	1		
16	5		
17	6		1
18	8		
19	1		1
20	4		1
21	1		
22	2		1
23	2		
24	4		
25	1		
26	2		
27	1		
28	1		
29	1		
30	3

Live	Dead
1	120	40
2	80	35
3	60	50
4	40	35
5	30	35
6	40	40
7	35	40
8	70	
9	65	
10	50	
11	75	
12	25	
13	50	
14	40	
15	45	
Min	25	35
Max	120	50
Average	55	39

Water	9.75
Water + Live Oysters	13.5
Live Oysters	3.75
Water	9.75
Water + All	15
All	5.25
Cultch	1.5

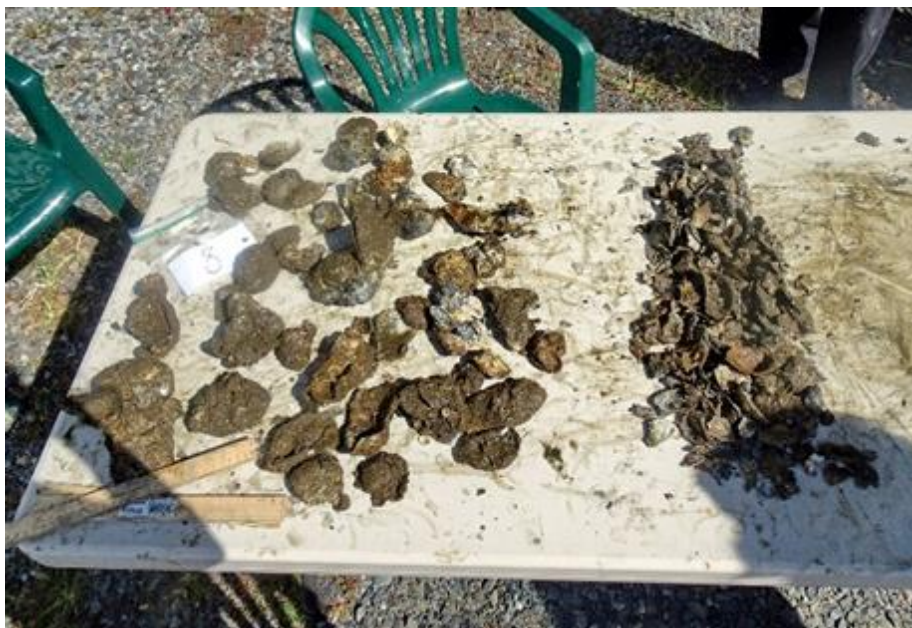
Sample 8 - September 26, 2022

Total	69	5	4
	Live	Box	Scar
1	1		
2	5		
3	1		
4	2		
5	1		
6	5		1
7	1		
8	1		1
9	3		
10	4		
11	1		
12	1		
13	1		
14	1		
15	1		
16	1		
17	4		1
18	1		
19	1		2
20	1		
21	1		
22	1		
23	3		
24	1		
25	1		
26	2		
27	1		
28	1		
29	3		
30	1		
31	3		2
32	4		
33	1		
34	3		1
35	6

Live	Dead
1	50	50
2	55	90
3	80	30
4	55	35
5	55	40
6	60	35
7	105	35
8	60	45
9	55	45
10	55	
11	90	
12	45	
13	55	
14	70	
15	45	
Min	45	30
Max	105	90
Average	62	45

Water	7.25
Water + Live Oysters	10
Live Oysters	2.75
Water	7.25
Water + All	11.5
All	4.25
Cultch	1.5

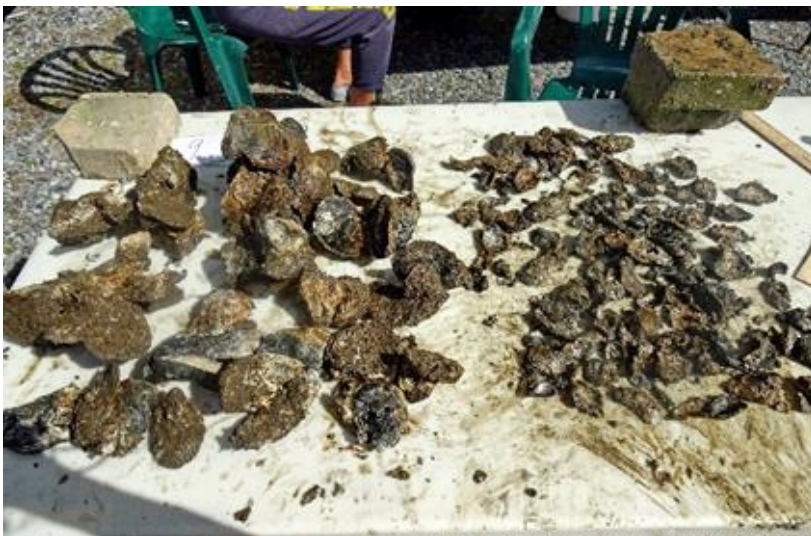
Sample 9 - September 26, 2022

Total	43	4	1
	Live	Box	Scar
1	0	1	
2	1		
3	11		
4	2		
5	3		
6	6		
7	2		
8	1		
9	2		1
10	1		
11	1		
12	1		
13	5		
14	1		2
15	1		
16	1		
17	1		
18	2		
19	1		
20	0		1

Live	Dead
1	100	110
2	90	70
3	80	65
4	90	60
5	40	53
6	70	
7	105	
8	95	
9	95	
10	70	
11	110	
12	105	
13	100	
14	100	
15	100	
Min	40	53
Max	110	110
Average	90	72

Water	12.75
Water + Live Oysters	16
Live Oysters	3.25
Water	13.75
Water + All	18
All	4.25
Cultch	1

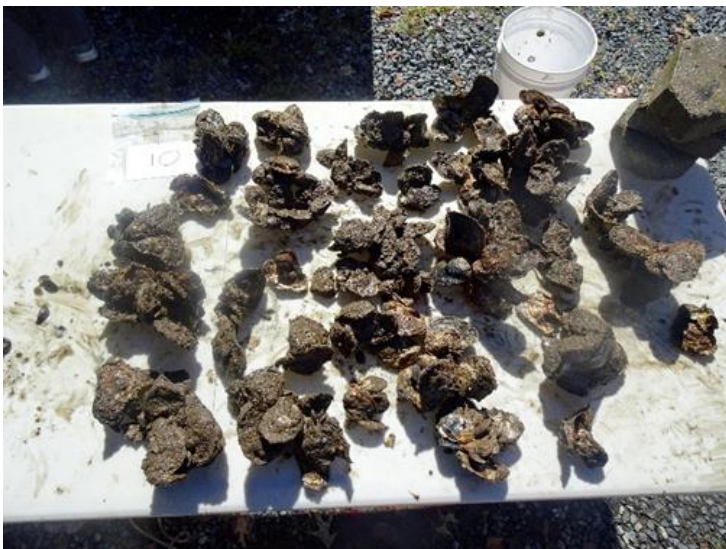
Sample 10 – October 6, 2022

Total	162	11	0
	Live	Box	Scar
1	2	1	
2	3	1	
3	4		
4	2		
5	2		
6	4	1	
7	3		
8	4		
9	5		
10	4		
11	2		
12	4	1	
13	1		
14	4		
15	3		
16	4	1	
17	3		
18	7	1	
19	2		
20	11		
21	1		
22	2		
23	6		
24	8		
25	10		
26	3	2	
27	5		
28	5		
29	1		
30	8	1	
31	5		
32	3	1	
33	9		
34	7		
35	8		
36	4		
37	2	1	
38	1

Live*	Dead
1		30
2		30
3		55
4		70
5		85
6		60
7		80
8		70
9		70
10		60
11		65
12		
13		
14		
15		
Min		30
Max		85
Average		61

Water	13
Water + Live Oysters	32.5
Live Oysters	19.5
Water	
Water + All*	
All	
Cultch*

***Note: There was no room in the buckets for the cultch**

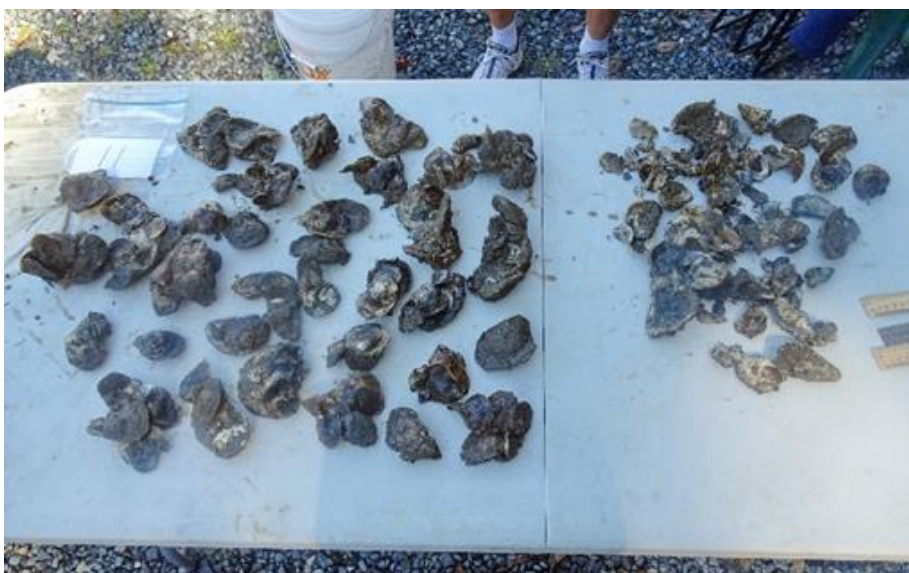
Count – Sample 11

Total	87	3	0
	Live	Box	Scar
1	5		
2	1		
3	1		
4	3		1
5	1		
6	1		
7	1		
8	1		1
9	2		
10	1		
11	3		
12	3		
13	5		
14	1		
15	1		
16	3		
17	1		
18	8		
19	1		
20	1		
21	4		
22	3		
23	2		
24	2		
25	3		
26	1		
27	1		
28	8		
29	1		
30	1		
31	1		
32	5		
33	5		1
34	1		
35	1		
36	1		
37	1		
38	2

Live*	Dead
1		40
2		60
3		65
4		
5		
6		
7		
8		
9		
10		
11		
12		
13		
14		
15		
Min		40
Max		65
Average		55

Water	7.25
Water + Live Oysters	10
Live Oysters	2.75
Water	7.25
Water + All	10.25
All	3
Cultch	0.25

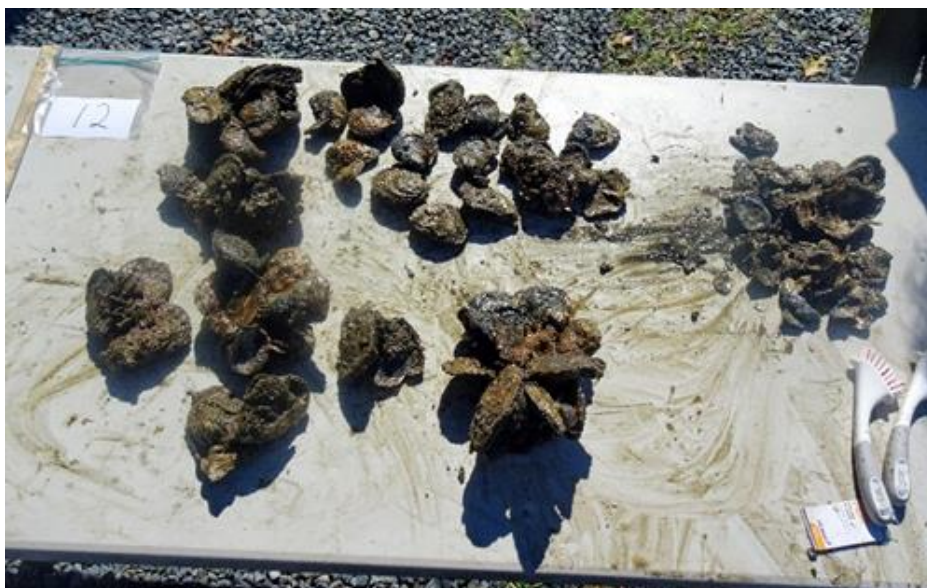
Sample 12 – October 6, 2022

Count – Sample 12			
Total	52	3	0
	Live	Box	Scar
1	5		
2	1		
3	1		
4	1		
5	1		
6	1		
7	1		
8	1		
9	1		
10	1		
11	1		
12	1		
13	1		
14	1		
15	1		
16	2		
17	2		
18	2		1
19	1		
20	5		
21	3		
22	7		1
23	11		1

Sizes in millimeters - Sample 12			
	Live		Dead
1	70		90
2	80		70
3	80		70
4	90		
5	80		
6	100		
7	60		
8	80		
9	95		
10	80		
11	80		
12	80		
13	70		
14	75		
15	70		
Min	60		70
Max	100		90
Average	79		77

Volume in Liters - Sample 12		
Water		15
Water + Live Oysters		19.5
Live Oysters		4.5
Water		15
Water + All		20
All		5
Cultch		0.5

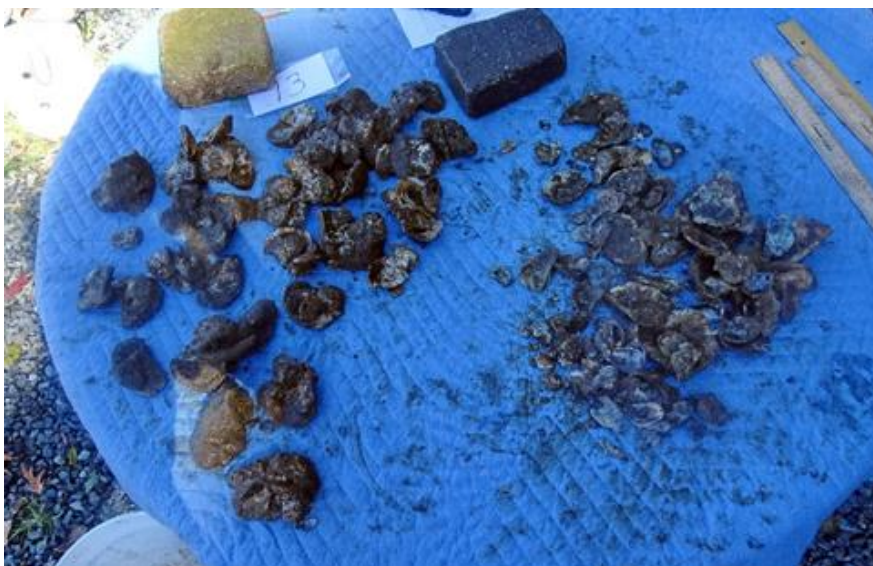
Sample 13 – October 6, 2022

Total	63	2	10
	Live	Box	Scar
1	6		
2	2		
3	4		
4	5		
5	2		
6	0		1
7	2		1
8	1	1	
9	4		
10	2		
11	1		
12	0		1
13	0	1	2
14	3		
15	1		
16	2		
17	1		
18	1		
19	0		1
20	1		2
21	3		
22	6		2
23	1		
24	1		
25	2		
26	5		
27	3		
28	2		
29	2

Live	Dead
1	50	40
2	65	35
3	40	50
4	50	50
5	70	50
6	90	50
7	75	55
8	45	40
9	55	60
10	40	45
11	70	55
12	80	45
13	45	
14	70	
15	70	
Min	40	35
Max	90	60
Average	61	48

Water	7.25
Water + Live Oysters	9
Live Oysters	1.75
Water	7.25
Water + All	10
All	2.75
Cultch	1

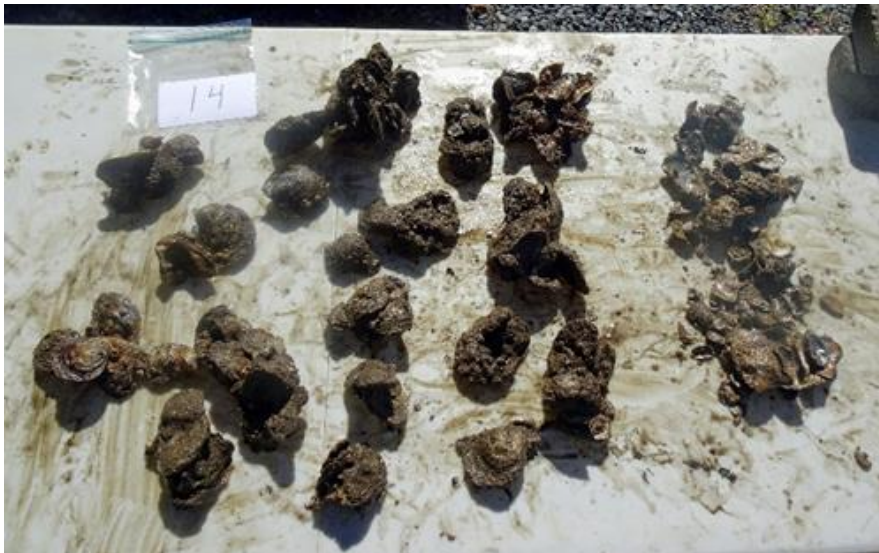
Count – Sample 14			
Total	87	3	1
	Live	Box	Scar
1	4		
2	1		
3	2		
4	1	1	
5	10		1
6	3		
7	2	1	
8	7		
9	1		
10	6		
11	3		
12	2		
13	9		
14	1		
15	1		
16	1		
17	9		
18	11	1	
19	6		
20	7

Sizes in millimeters - Sample 14			
	Live*		Dead
1			70
2			50
3			40
4			70
5			
6			
7			
8			
9			
10			
11			
12			
13			
14			
15			
Min			40
Max			70
Average			58

Volume in Liters - Sample 14		
Water		10
Water + Live Oysters		13
Live Oysters		3
Water		10
Water + All		13.5
All		3.5
Cultch		0.5

*Volunteers forgot to measure live oysters

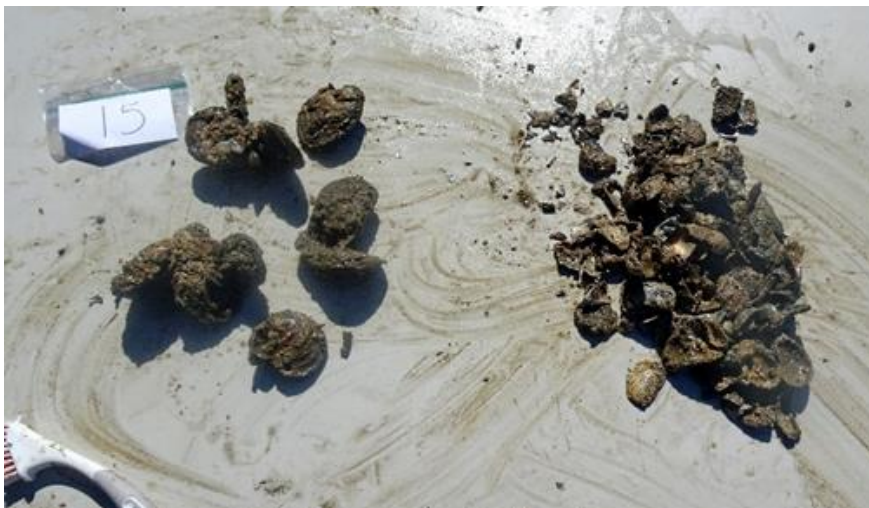
Count – Sample 15

Total	10	0	0
	Live	Box	Scar
1	1		
2	1		
3	3		
4	2		
5	3

Live	Dead
1	100	
2	80	
3	100	
4	90	
5	95	
6	100	
7	100	
8	95	
9	95	
10	90	
11		
12		
13		
14		
15		
Min	80	
Max	100	
Average	95

Water	3.5
Water + Live Oysters	4.5
Live Oysters	1
Water	3.5
Water + All	5
All	1.5
Cultch	0.5

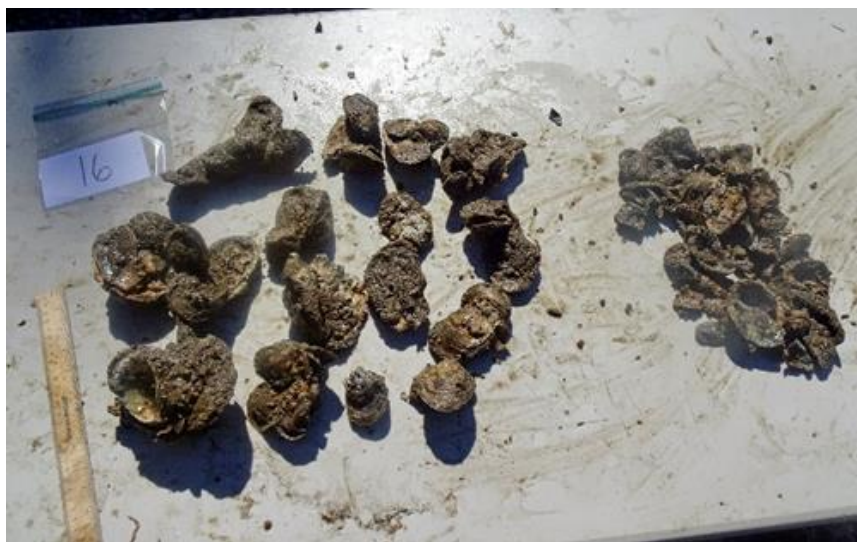
Sample 16 – October 6, 2022

Total	43	3	0
	Live	Box	Scar
1	3		
2	2		
3	1		
4	1		
5	3		1
6	1		
7	1		
8	2		
9	2		
10	4		
11	2		1
12	1		
13	1		
14	3		
15	4		1
16	5		
17	7

Live	Dead
1	70	55
2	50	45
3	70	50
4	120	
5	80	
6	100	
7	90	
8	95	
9	60	
10	85	
11	60	
12	70	
13	55	
14	110	
15	110	
Min	50	45
Max	120	55
Average	82	50

Water	8.75
Water + Live Oysters	9.5
Live Oysters	0.75
Water	8.75
Water + All	10
All	1.25
Cultch	0.5

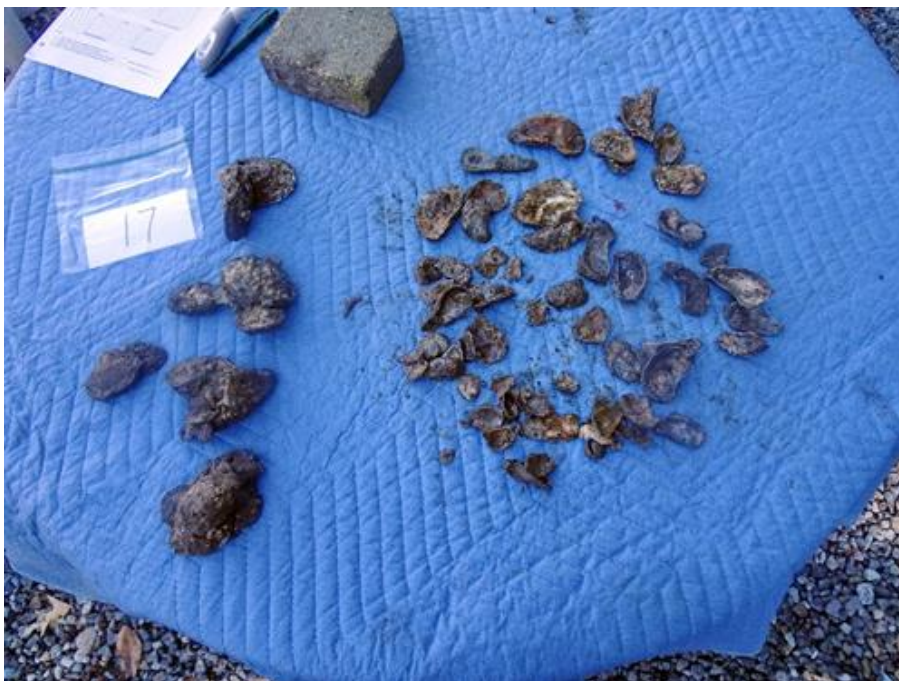
Sample 17 – October 6, 2022

Total	12	0	0
	Live	Box	Scar
1	1		
2	2		
3	3		
4	4		
5	2

Live		Dead
1	95		
2	90		
3	65		
4	70		
5	65		
6	75		
7	85		
8	65		
9	60		
10	45		
11	41		
12	50		
13			
14			
15			
Min	41		
Max	95		
Average	67

Water		4
Water + Live Oysters		5
Live Oysters		1
Water		4
Water + All		5.25
All		1.25
Cultch		0.25

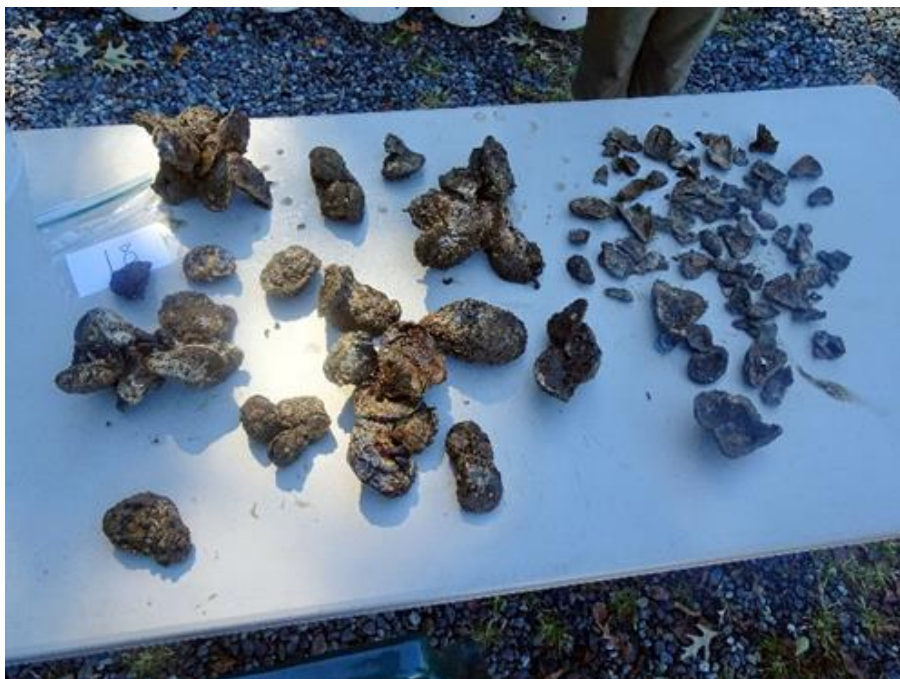
Sample 18 – October 6, 2022

Count – Sample 18			
Total	39	3	0
	Live	Box	Scar
1	1		
2	1		
3	1		
4	1		
5	1		
6	1		
7	1		
8	1		1
9	3		1
10	2		
11	2		
12	2		
13	1		
14	3		
15	1		
16	4		
17	5		1
18	8

Sizes in millimeters - Sample 18			
	Live		Dead
1	100		57
2	75		60
3	140		70
4	70		
5	90		
6	100		
7	70		
8	60		
9	60		
10	120		
11	90		
12	110		
13	90		
14	110		
15	90		
Min	60		57
Max	140		70
Average	92		62

Volume in Liters - Sample 18		
Water		11
Water + Live Oysters		15.5
Live Oysters		4.5
Water		11
Water + All		16.5
All		5.5
Cultch		1

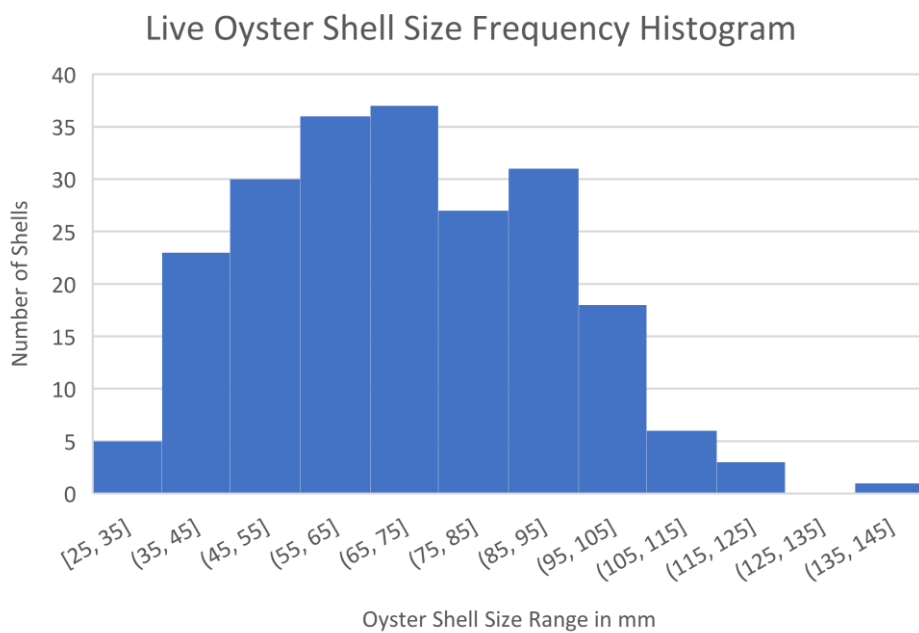
We randomly chose up to 15 live oysters from each site to measure. Some sites had fewer than 15 oysters. We measured a total of 217 live oysters. Below is a histogram showing the live oyster size distributions.

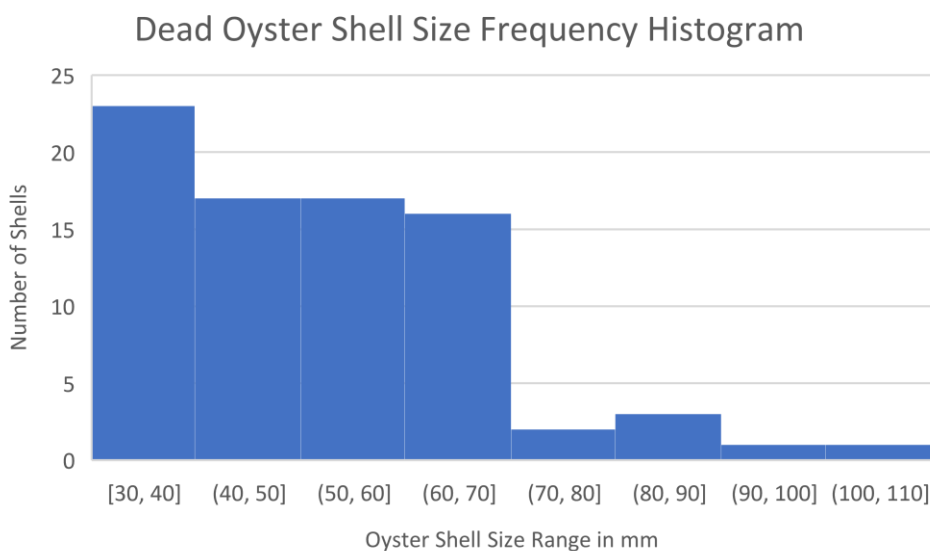
We randomly chose up to 15 dead oysters from each site to measure. Several sites had fewer than 15 dead oysters. We measured a total of 80 dead oysters. Below is a histogram showing dead oyster size distributions.
